MassDEP RTN 3-23246

Release Abatement Measure Status Report No. 3

50 Tufts Street, Somerville, Massachusetts

October 29, 2024
Project No. 045163

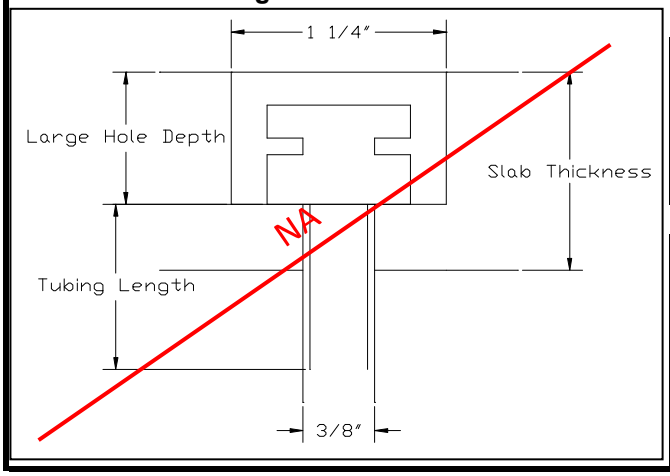
SV1			
Slab Thickness:	4"			
Tubing Length:	NA			
Type of Material Under Slab:				
Large Hole Depth:	1.75"

Comments:
- installed stainless steel VaporPin in point
- NA = not applicable

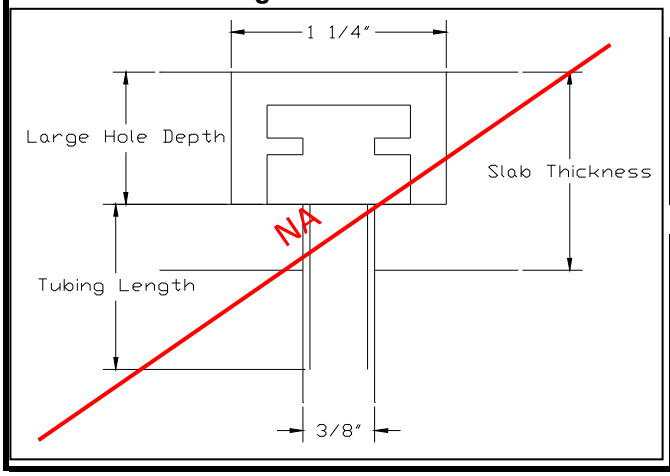
SV2			
Slab Thickness:	4"			
Tubing Length:	NA			
Type of Material Under Slab:				
Large Hole Depth:	1.75"

Comments:
- installed stainless steel VaporPin in point
- NA = not applicable

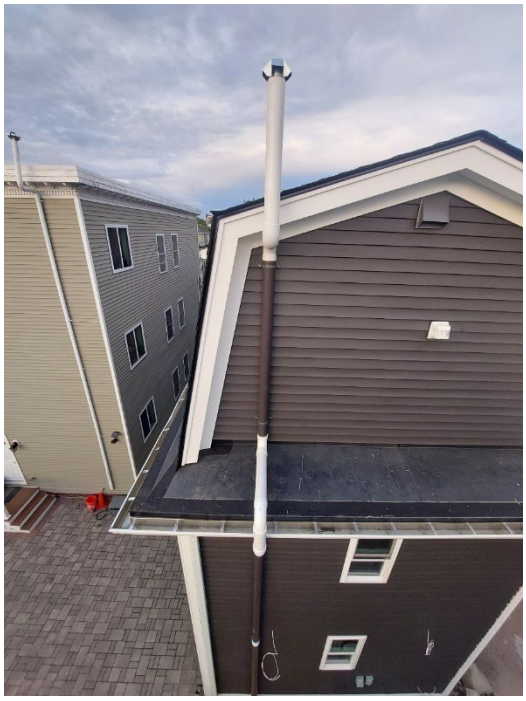
Photo 1. Installing riser pipe

Photo 2. Completed riser pipe

Between September 23 and 24, 2024, A-Zoulias Environmental Enterprises (A-Zoulias) of Hudson, New Hampshire extended the sub-slab vapor mitigation system exhaust riser piping to above the roof. A photo log is in Appendix D.
